MITCHELL FIELD WATER TOWER ASSESSMENT

Report of Findings

230515.00
Town of Harpswell, ME
March 2017

Mitchell Field Navy Facility Tank 100,000 Gallon Elevated Tank Condition Assessment Report

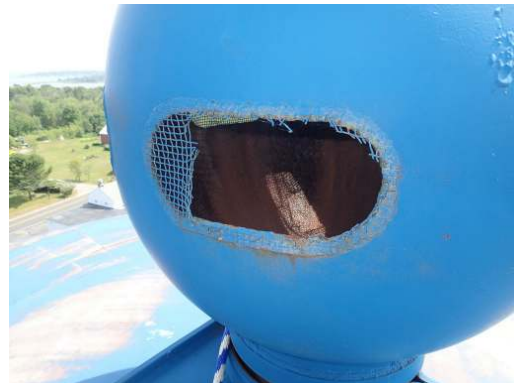
Showing a hole in the finial ball screen.

Showing a hole in the finial ball screen that should be repaired if the tank is to be returned to service.

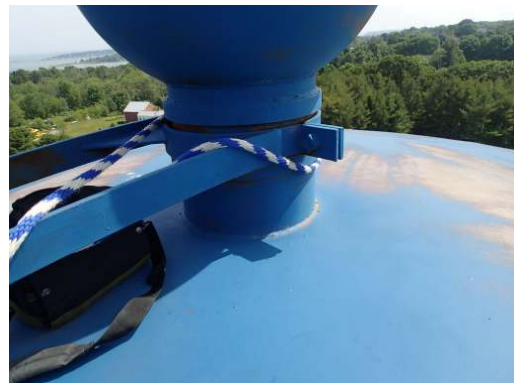
Showing corrosion on the interior of the finial ball which is open to the tank interior

The finial ball neck appears to be in good condition

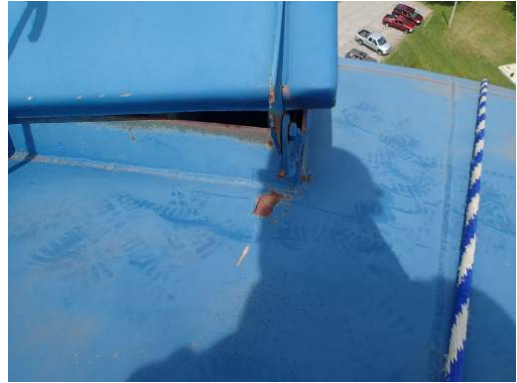
The hinges on the single 24"x24" hatch cover are broken

Showing one of two broken hatch hinges.

2. The overflow pipe opening should be equipped with a screen and flapper assembly.
3. The roof hatch cover hinges were found to be in poor condition with one broken at the welded connection to the roof and the other severely bent and damaged. The cover was removed to ground level during this inspection but should be replaced if this tank is to be returned to active service.

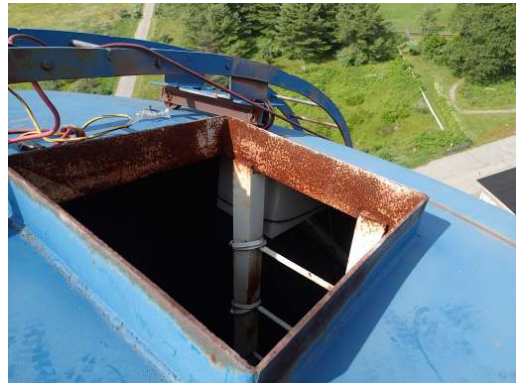
The hatch cover was removed for safety reasons due to poor structural integrity of the hinges

Extensive corrosion on the hatch neck does not appear to be affecting the structural integrity at this time

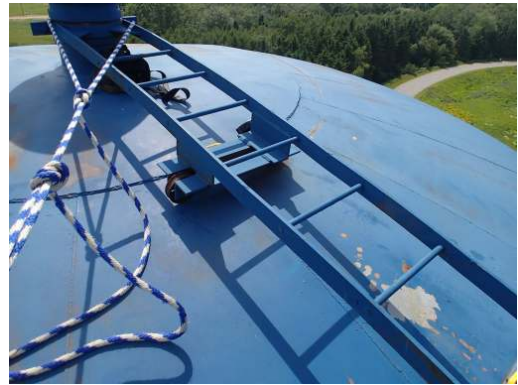
The revolving roof ladder connection bracket to the finial ball neck appears in sound condition but there is corrosion on the neck surfaces

Roof revolving ladder appears in sound structural condition.

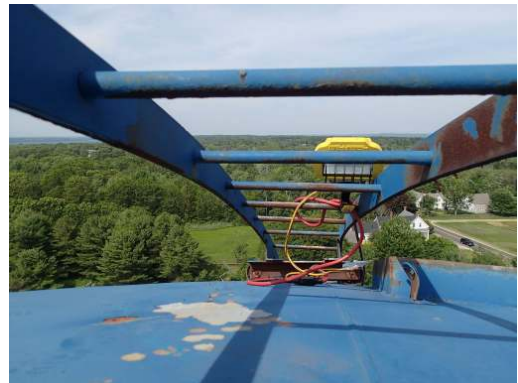
Showing corrosion of the roof ladder side rails.

Showing extensive corrosion on the ladder rungs and rails.

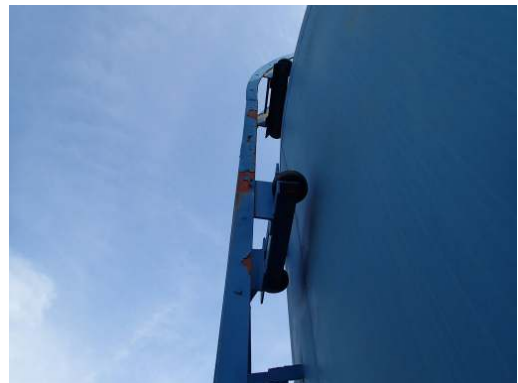
Shows medium grade corrosion on the underside of the ladder and wheel assembly.

The coatings on the revolving ladder are delaminating at the prime coat

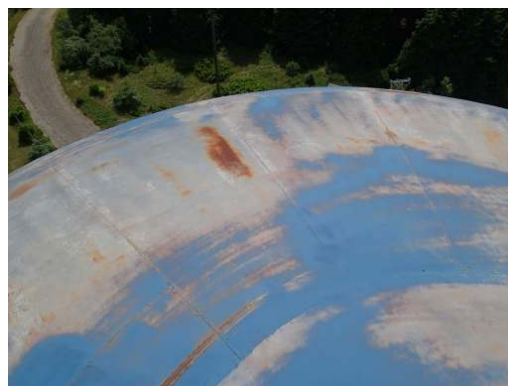
The exterior roof is in fair to poor condition with heavy weathering revealing the underlying coatings.

Roof appears in sound structural condition with only light rust and weathering noted.

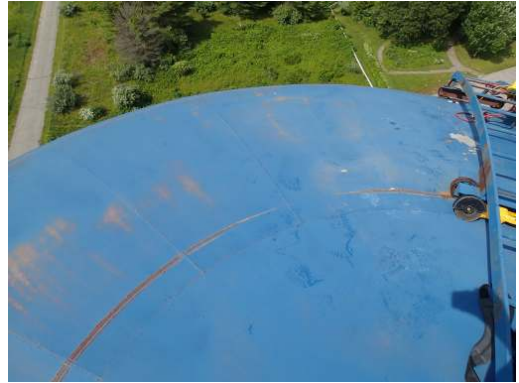
Light rust and severe weathering was observed throughout the roof plates

Shows evidence the top coat is chalked and degraded

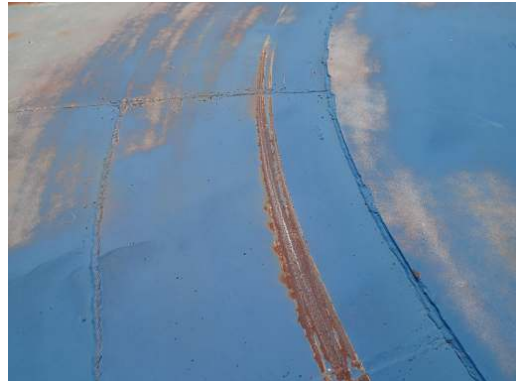
Showing weathering and abrasion damage along the center roof area

Showing abrasion damage around the center dollar plate due to the roof ladder wheels

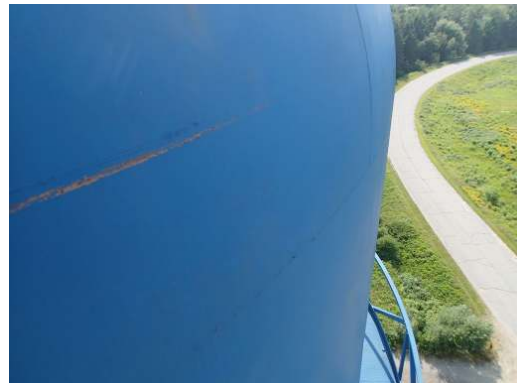
The coatings on the roof knuckle are weathered and there is evidence of abrasion damage from the revolving ladder

Showing abrasion damage from the revolving roof ladder.

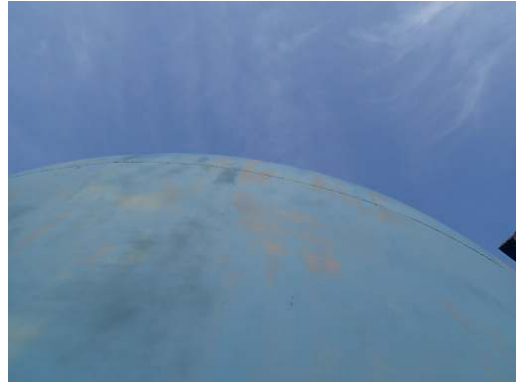
Shows light rust and soiling present on the shell plates

Showing top coat weathering along the upper shell surfaces

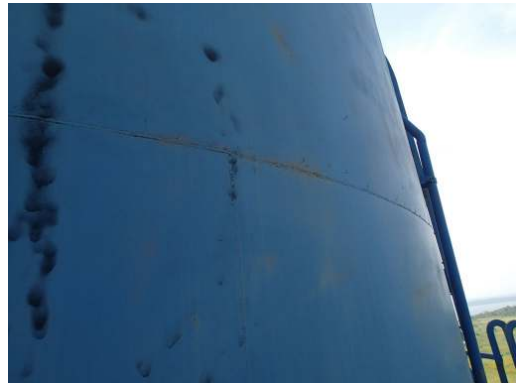
Showing graffiti on the exterior shell.

Showing light rust and weathering on the exterior shell

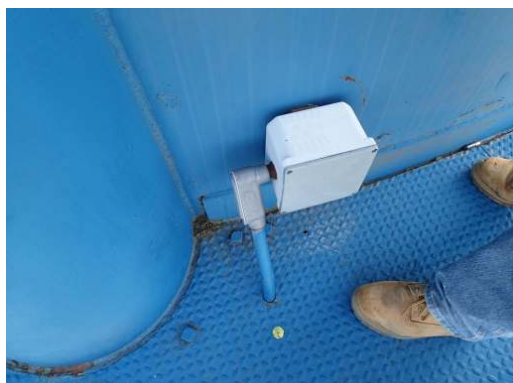
Showing corrosion on a cover plate installed to one of the leg column post heads

Showing a junction box and associated conduit for cathodic wiring at the balcony level.

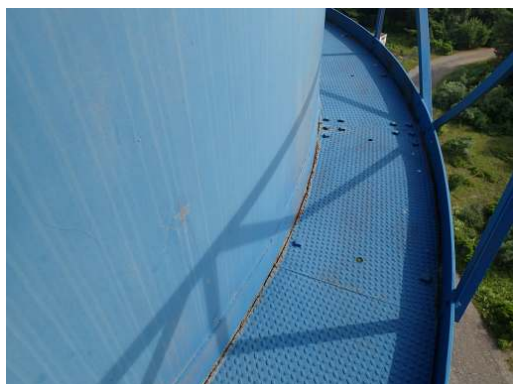
Showing heavy corrosion with possible metal loss at the shell to balcony junction

The balcony walkway are in generally good condition except for heavy corrosion along the edges.

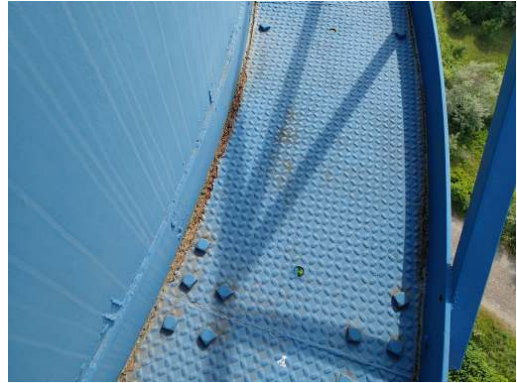
Showing a gap at the shell to balcony junction with heavy rust on the shell plate

Shows evidence of heavy rust and scale with slight to moderate metal loss of associated surfaces

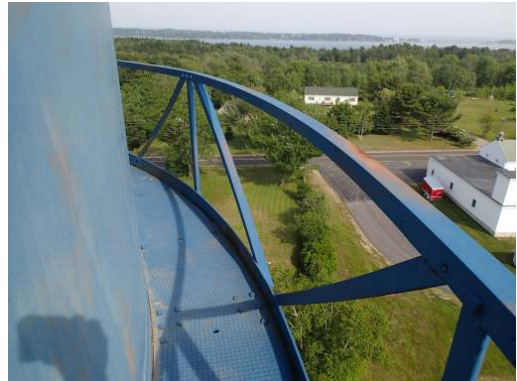
Shows scattered areas of coating failure and corrosion on the handrails.

The balcony handrails are in good structural condition although there is scattered areas of degradation

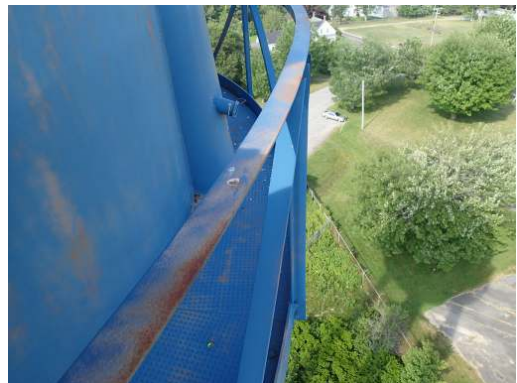
Shows a davit assembly secured to the balcony handrail

Shows an area of significant light to medium grade rust on the balcony handrail

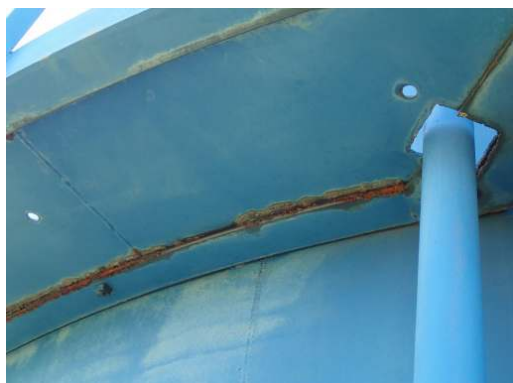
Showing corrosion along the bolts and edges where a leg column attaches to the balcony.

Showing corrosion along the underside of the balcony walkway at the junction with what appears to be a supporting angle

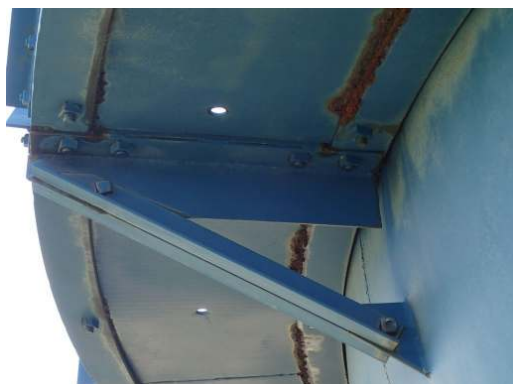
Showing corrosion and at least slight to moderate metal loss along the underside of the balcony.

The coatings on the visible balcony support braces appear in sound condition

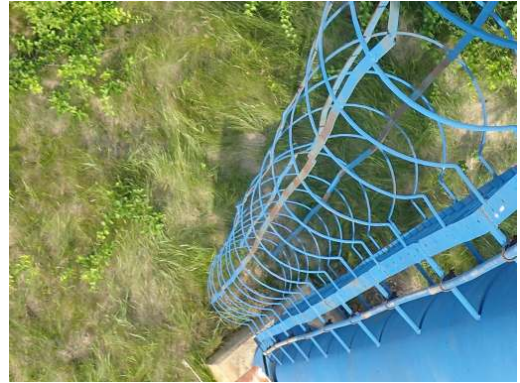
The leg column access ladder appears in sound structural condition with no obvious deficiencies observed

The coatings on the ladder safety cage are in only fair to poor condition

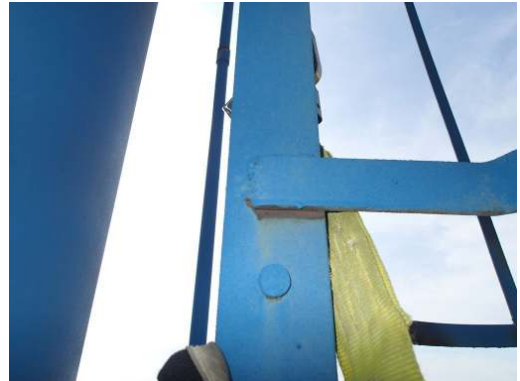
Several of the vertical ribs of the ladder cage are bent which has compromised the welds at several locations

Showing corrosion on one of the cage connections to the ladder

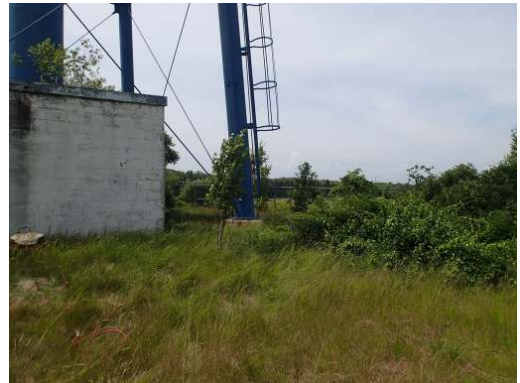
Light rust on the weld seams of several ladder to leg column brackets does not appear to be affecting the structural integrity

The leg column access ladder terminates at ground level and there is no security gate to prevent unauthorized access

- Blast clean and recoat the interior and exterior of the tank;
- Repair and resurface existing tank foundations;
- Install gate and lock on exterior ladder;
- Replace or repair interior ladder
- Complete repairs on exterior ladder;
- Repair pitting and metal loss on the interior of the tank;
- Repair overflow pipe and install screen and flapper;
- Install roof hatch cover with lock; and
- Replace vent assembly.

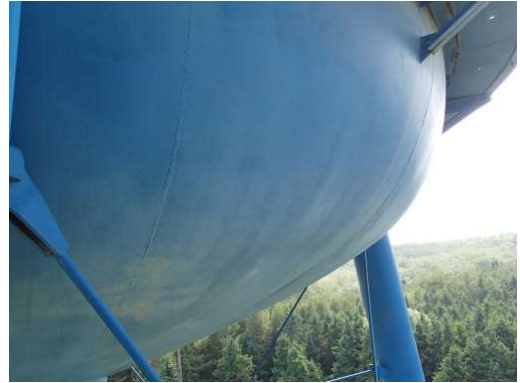
The bowl surfaces visible from the access ladder are weathered but exhibit little corrosion

Shows significant weathered coating on the bowl surfaces

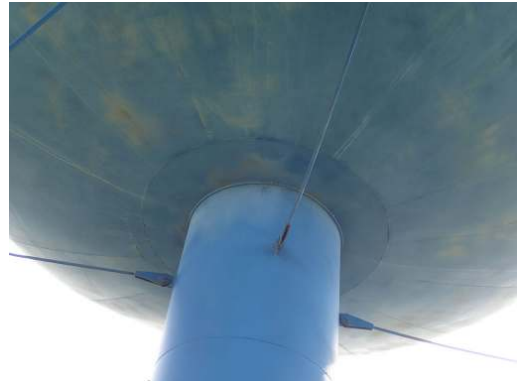
Shows significant weathered coating and scattered areas of light rust on the bowl surfaces

The riser to bowl junction appears in sound structural condition with no obvious deficiencies observed

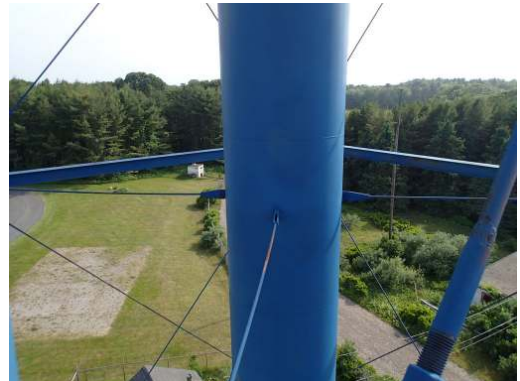
Shows an overall view of the riser and associated radial rods

Shows rust on a riser radial rod with no evidence of any structural issues

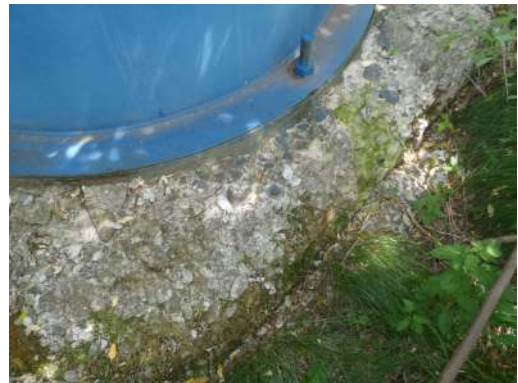
Corrosion is present on all bolted connections as well as where the tank ID plate was originally attached

The riser foundation is in poor condition with significant degradation of the concrete exposing large aggregate

The foundations under the four tank support legs and the center riser are in need of repairs. Jim Sturgis, a Woodard & Curran structural engineer, completed a structural condition assessment of the tank's concrete foundations. His assessment is captured in a memorandum that is found in Appendix C of this report. The assessment concluded that the column leg pier foundations were in fair to poor condition while the center riser pipe foundation was in very poor condition. The assessment recommends conducting preliminary test pit exploration of the center riser pipe foundation, repairing the concrete for all five foundations, and demolishing the existing concrete block utility building at the base of the center riser pipe within the next six to twelve months. The estimated cost of these repairs is \$47,000, which includes contingency and engineering costs and is broken down in greater detail in Appendix C.

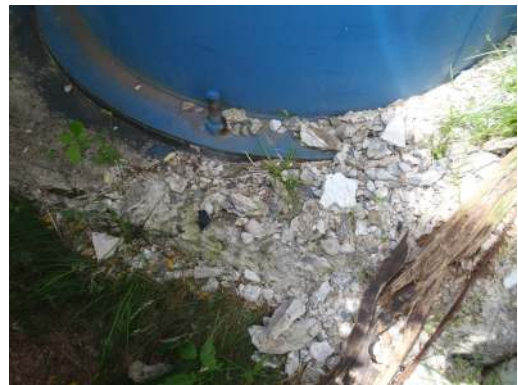
Shows the base of the riser adjacent to a concrete block building

Shows concrete rubble from the degraded riser foundation

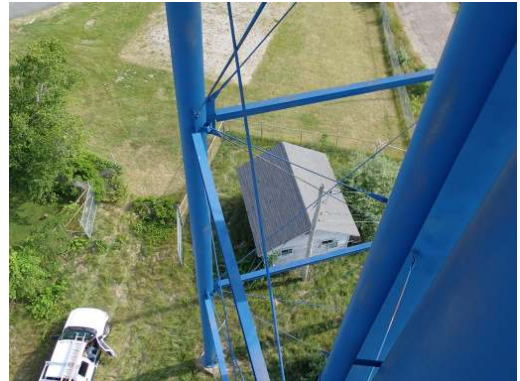
Shows significant weathering on the leg columns

Shows the sway rod and strut connections to the leg columns to be in good condition

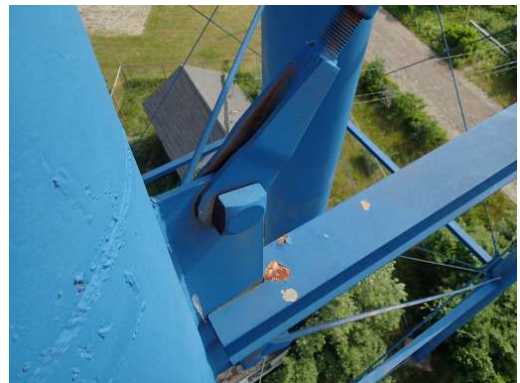
The sway rod turnbuckles are experiencing light rust but appear in good structural condition.

Showing rust on the interior of a sway rod yoke and coating delamination and surface corrosion on the adjacent strut

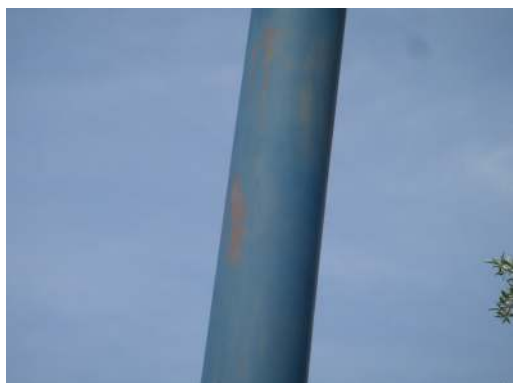
The sway rod connections appear structurally sound but are exhibiting light rust on the threads

Shows the coatings on the leg columns to be weathered but there is little corrosion

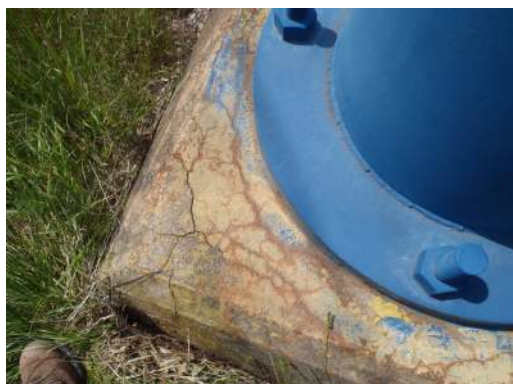
The leg column base plates appear in sound structural condition with no significant coating degradation observed

Shows what appears to be surface cracking in one of the leg column footings

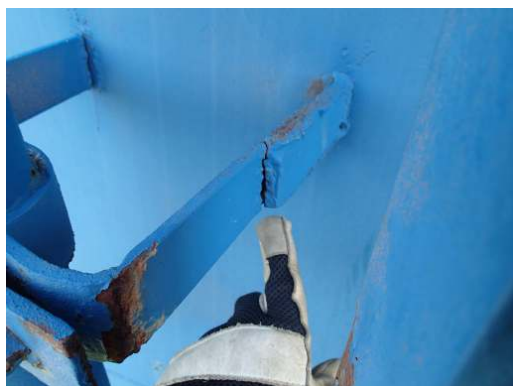
The coatings on the overflow pipe bracket above the balcony is in poor condition and there is evidence of a cracked weld

Showing a crack on the overflow pipe standoff bracket at the balcony level

1. There is one broken overflow pipe support bracket above the balcony level, and an additional severely deteriorated bracket at ground level which is exhibiting severe metal loss and is missing a retention nut that will require repairs when this tank is next maintained. In order to ensure the structural integrity of the pipe during future overflow events, the bracket at the balcony level should be repaired and welded back into place and the bracket at ground level should be replaced in its entirety.

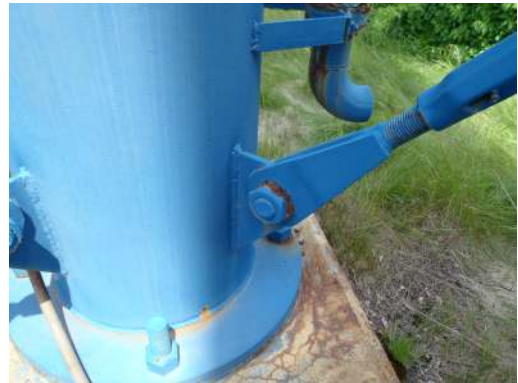
Shows heavy rust, scale and associated moderate metal loss as well as a missing nut on the lower overflow bracket

The overflow terminates approximately 20"± from grade with no evidence of a splash pad or riprap area for drainage

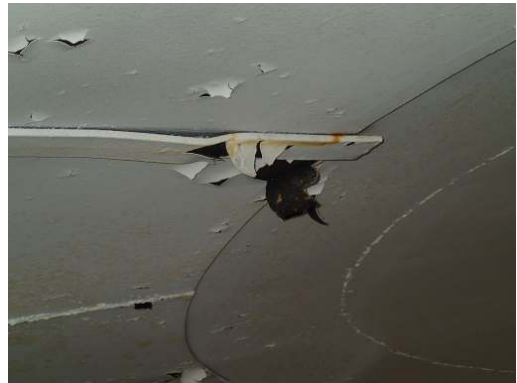
Delamination was noted along the center roof as seen near the vent opening.

Showing delamination along the roof plates and seams.

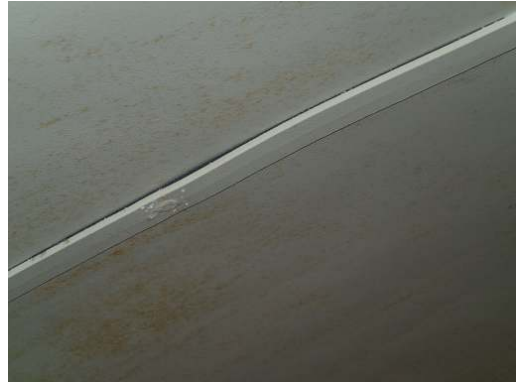
Showing delamination and corrosion along the roof plates and seams.

Showing light rust breaking thru the coatings on the underside of the roof plates.

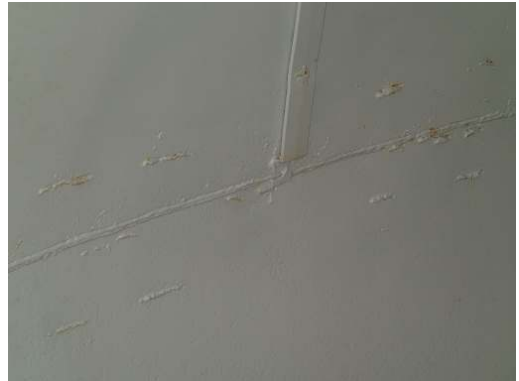
Shows backing strip in place on the underside of the roof and knuckle plates

Showing light rust on the erection burrs remaining on the knuckle and shell plates

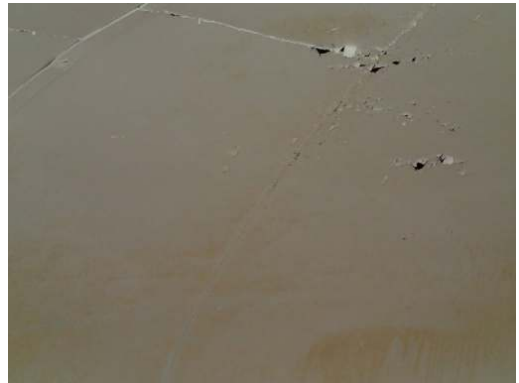
Shows corrosion under the backing straps along the roof and knuckle plates

Showing delamination along the upper roof plates and seams with additional light rust present on the lower surfaces

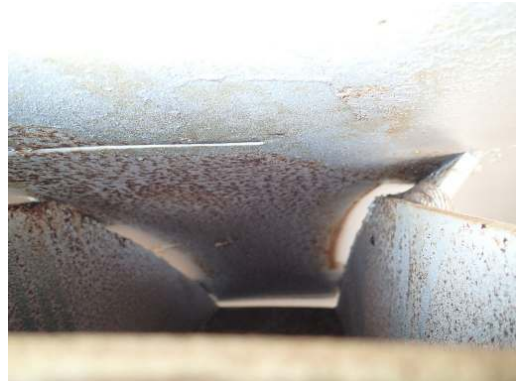
Sideview of the weir box configuration showing the box is stepped off of the roof and supported by gusset plates only with no access for painting

Interior view of the weir box showing corrosion along inaccessible surfaces

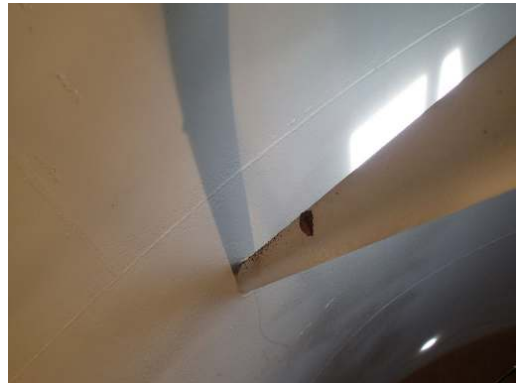
Corrosion is occurring on the internal portion of the overflow pipe.

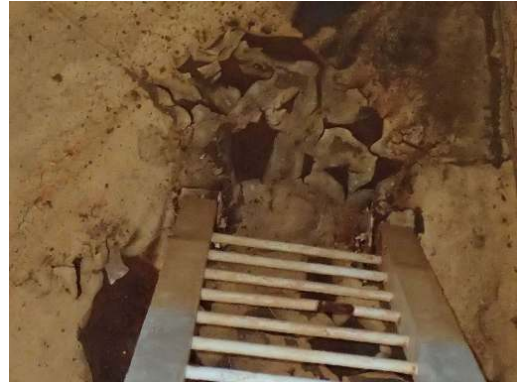
Showing an area of coating delamination and corrosion on the interior bowl.

Showing delamination of the coatings on the bowl surface at the base of the interior ladder.

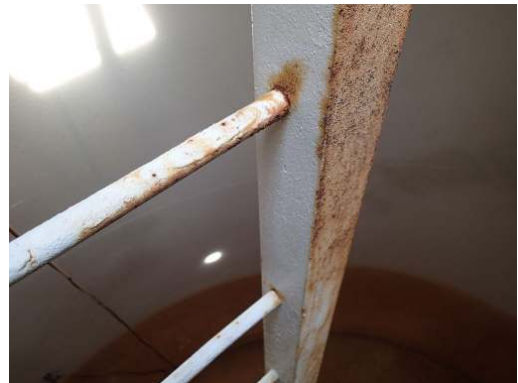
The interior ladder appears in sound structural sound condition but there is significant corrosion along the rungs and rails. There are no mid point stabilizers.

Closeup of corrosion on the interior ladder.

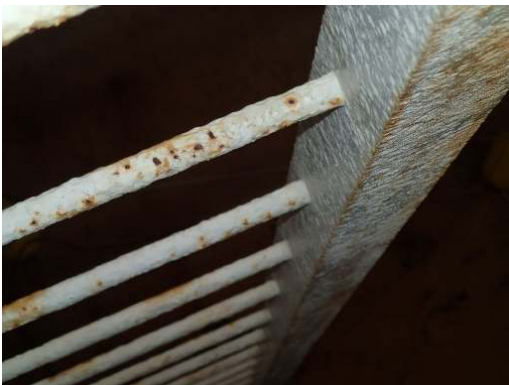
Closeup of corrosion and past metal loss on the interior ladder.
